## Failure of Cap Screws on NPS 30 PN 100 Tilting Disc Check Valves

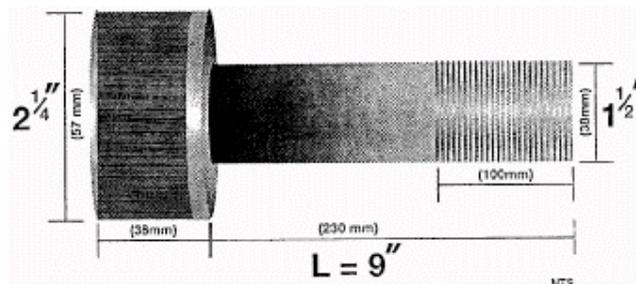
### Cap Screw

In March 1997, a check valve located on pump station discharge piping failed resulting in a significant spill of crude oil. The failed check valve was located underground just downstream of the pump building. The leaking check valve resulted from the failure of several cap screws that are used to fasten the two pieces of its valve body together. The check valve was a NPS 30 PN 100 flange-by flange Tilting Disc Check Valve (complete with dashpot) manufactured by Dominion Engineering Works Ltd. in 1967. Later in 1997, another failure occurred at the same location involving the cap screws of an identical replacement check valve.

The cause of the incidents was hydrogen embrittlement of the valve cap screws. More specifically, embrittlement and fracture of the studs resulted from the presence of a susceptible material, a high tensile stress, and a source of hydrogen. The source of hydrogen was attributed to the cathodic protection system acting on the valve even though it was determined that the cathodic protection system was operating at normal levels at the time of the incidents. The cap screws did not have any protective coating applied to them making them susceptible to the diffusion of hydrogen in the material.

- a) Pipeline Companies should determine if flange-by-flange Tilting Disc Check Valves manufactured by Dominion Engineering Works Ltd. exist on their pipeline systems.
- b) If so, the Pipeline Company should excavate and examine each of the valve's cap screws for hydrogen-related damage and make the necessary repairs.
- c) Pipeline Companies should consider examining similar types of installations on their systems for hydrogen-related damage (e.i. other buried bolted assemblies).

Note: The company to which these incidents occurred has initiated an action plan consisting of the excavation, inspection, necessary replacement and recoating of cap screws on their system. The new cap screws used to replace the damaged cap screws are ASTM A 320 L7 with rolled threads.
